The 2003 San Simeon Earthquake

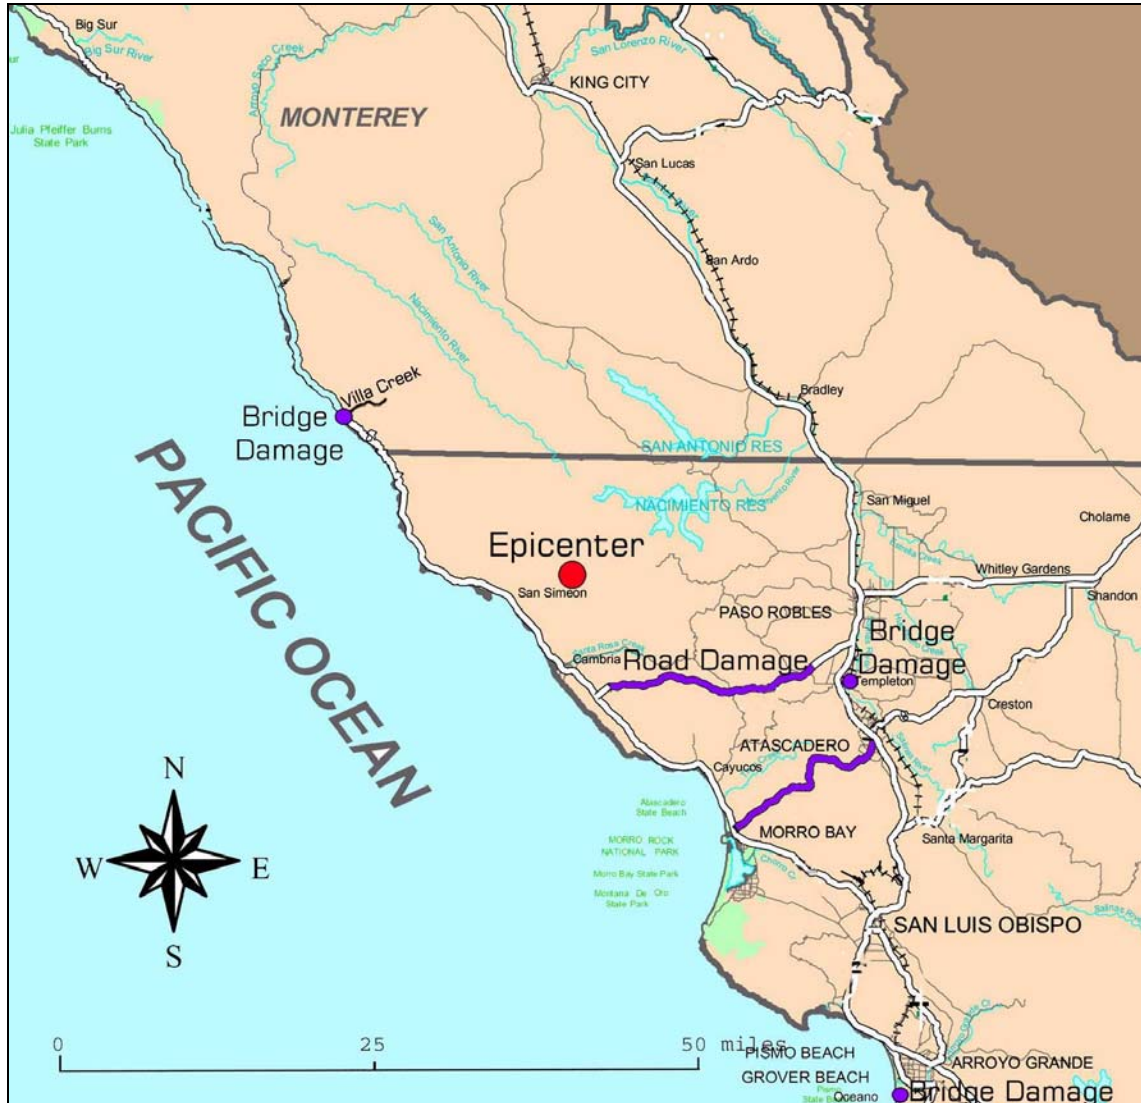
Fig. 7.2. Map showing major damage locations for roads and bridges.

The most significant road damage was at State Routes 41 and 46 between US-101 and SR-1 (Figures 7.2 and 7.3). Ron Richman, the District 5 geotechnical engineer writes, *"We observed rockfalls originating from cut slopes on State Route 41. The Route 46 damage included surging of landslides, spreading of tall embankments and fissuring at*

the contacts between the original ground and tall embankments. We did not observe significant effects on the bridges in the region. We looked for indications of liquefaction, but found none.” This damage was sufficient to keep Caltrans’ road crews busy with traffic control and roadway repairs for several weeks after the earthquake.
